DEPARTMENT OF TRANSPORTATION

Quality Assurance and Source Inspection

Contract #: 04-0120F4Cty: SF/ALA Rte: 80 PM: 13.2/13.9File #: 1.28**WELDING INSPECTION REPORT****Resident Engineer:** Casey, William**Address:** 333 Burma Road**City:** Oakland, CA 94607**Report No:** WIR-030109**Date Inspected:** 25-Sep-2013**Project Name:** SAS Superstructure**OSM Arrival Time:** 700**Prime Contractor:** American Bridge/Fluor Enterprises, a JV**OSM Departure Time:** 1730**Contractor:** American Bridge/Fluor Enterprises, a JV**Location:** Job Site**CWI Name:** Bernie Docena**CWI Present:** Yes No**Inspected CWI report:** Yes No N/A**Rod Oven in Use:** Yes No N/A**Electrode to specification:** Yes No N/A**Weld Procedures Followed:** Yes No N/A**Qualified Welders:** Yes No N/A**Verified Joint Fit-up:** Yes No N/A**Approved Drawings:** Yes No N/A**Approved WPS:** Yes No N/A**Delayed / Cancelled:** Yes No N/A**Bridge No:** 34-0006**Component:** SAS Tower**Summary of Items Observed:**

WELDING INSPECTION REPORT

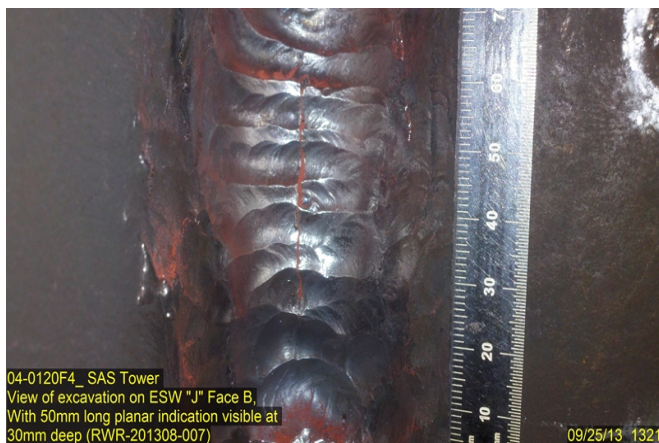
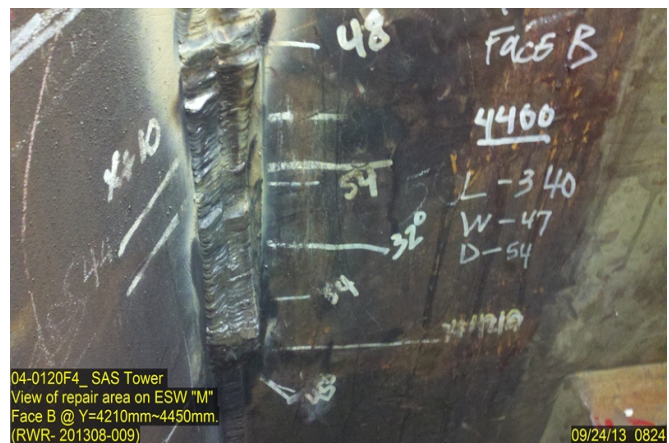
ESW N-042, Location "J"-Face B:

The QA Inspector observed ABF welder Donald Plumb (WID-0891) performing excavation of ESW "J" at Face B, Y= 3460mm,3480mm,3550mm,3570mm to verify remove planar indications observed during Ultrasonic Testing (UT) with pulse/echo & pitch/catch. Mr. Plumb was performing the excavation using an air carbon arc cutter and a grinder. Mr. Plumb was instructed by ABF QC Inspector Bernie Docena to notify him when indications are visible to allow QC/QA time to inspect the excavation. The repair location was noted as:

Weld excavated at: D=20mm- No indications observed.

Weld excavated at: D=30mm- 50mm long planar indication observed @ Y-3400mm.

Weld excavated at: D=40mm- Planar indication removed. No other indications observed.

Excavation Length: (Y-3380mm~3780mm)

After grinding to bright metal the QC Inspector performed Magnetic Particle Testing (MT) of the final excavation. The QC Inspector stated the excavation appears to be free of discontinuities and he would complete ABF daily inspection report and magnetic particle testing report to detail the findings. Mr. Docena also stated that since the indication observed & removed at 30mm deep appeared to be a significant planar indication (centerline crack) the repair will also be performed at Face "A" of the ESW weld at this Y location to ensure complete removal of the discontinuity. The QA Inspector also performed an MT verification of the final excavation. See TL-6028 for additional details on items inspected on this date. Mr. Plumb was later observed setting up the Miller ProHeat 35 induction blankets at the repair location in preparation for SMAW of the repair excavation.
